## *Clearance Analysis of Node 3 Aft CBM to the Stowed FGB Solar Array*

*Donn Liddle*

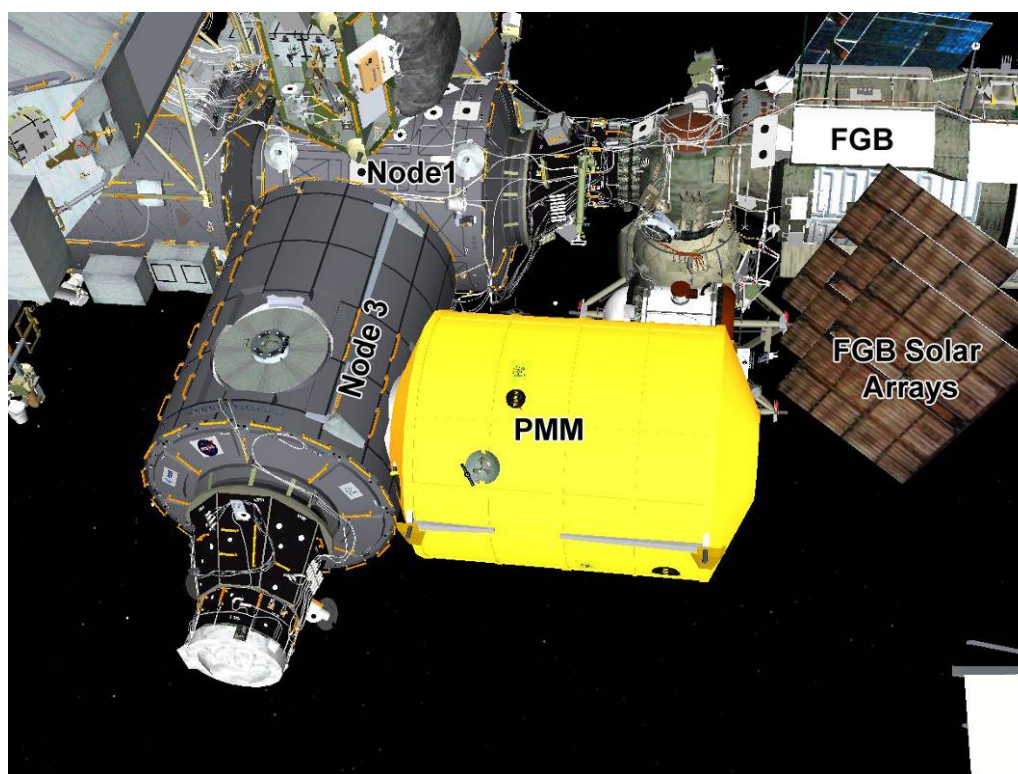
In early 2011, the ISS Vehicle Configuration Office began considering the relocation of the Permanent Multipurpose Module (PMM) to the aft facing Common Berthing Mechanism (CBM) on Node 3 to open a berthing location for visiting vehicles on the Node 1 nadir CBM. In this position, computer-aided design (CAD) models indicated that the aft end of the PMM would be only a few inches from the stowed Functional Cargo Block (FGB) port solar array (see figure 1).

*Figure 1.— Proposed relocation site for PMM with minimum clearance to FGB solar arrays.*

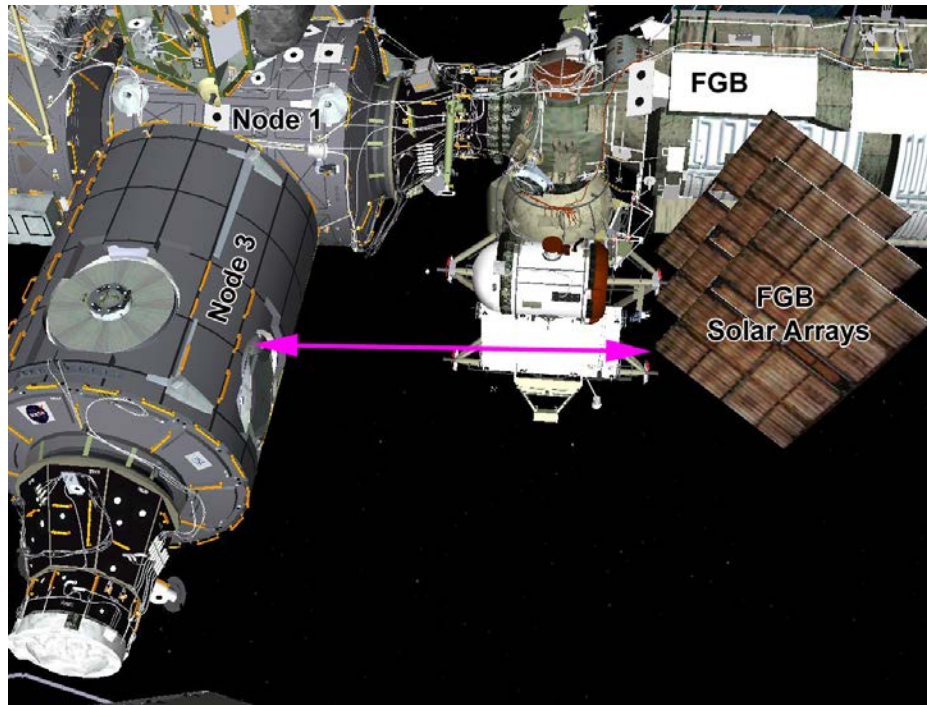
To validate the CAD model clearance analysis, in the late summer of 2011 the Image Science and Analysis Group (ISAG) was asked to determine the true geometric relationship between the on-orbit aft facing Node 3 CBM and the FGB port solar array (see figure 2).

*Figure 2.— Photogrammetric analysis of the aft face of Node 3, port side of Node 1, port side of pressurized mating adapter 1 (PMA1), port side of the FGB hemisphere, and port FGB solar arrays to determine the absolute location of the port FGB solar arrays relative to Node 3.*

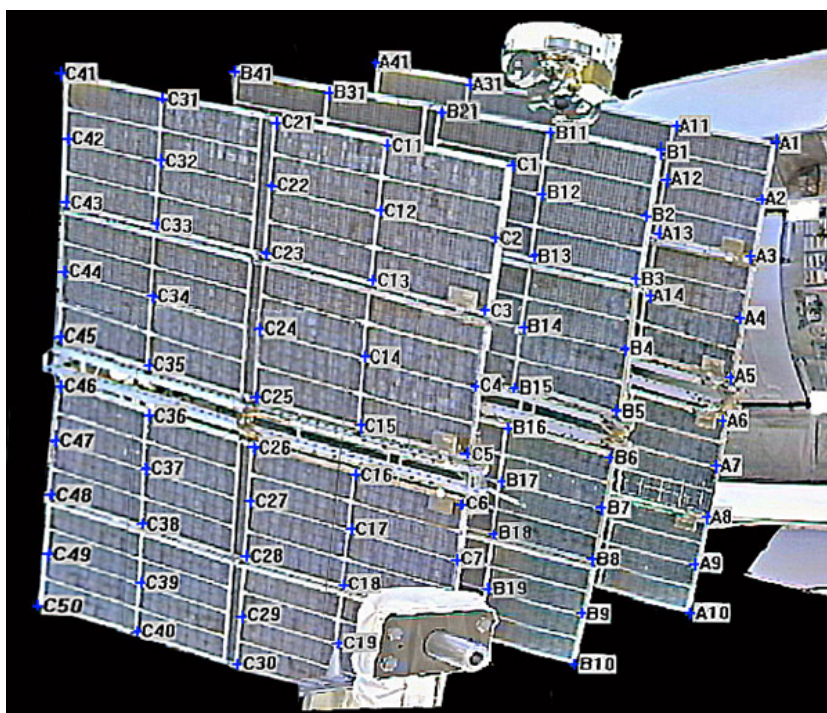
The results of this analysis produced the measured coordinates of 116 points distributed across the face of the FGB solar array panels (see figure 3) along with propagated uncertainty estimates in each coordinate axis. These results were sent to the ISS Vehicle Configuration Office, which sent them to the Configuration Analysis Modeling and Mass Properties (CAMMP) team for comparison with the Russian-provided CAD model for the retracted FGB solar arrays.

*Figure 3.— Points measured on the port FGB solar array in the ISSACS coordinate system defined by Node 3*

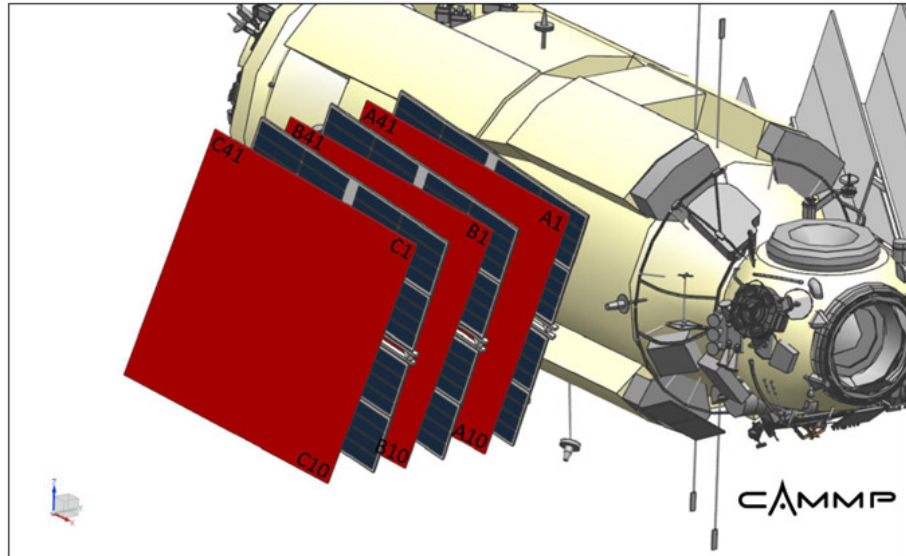
The CAMMP analysis unexpectedly showed that the measured location of the port FGB solar array was up to 41-in. further outboard than the design and was slightly twisted about its rotational axis (as shown in figures 4 and 5).

Figure 4.— Delta configuration between the measured coordinates of the port solar array (shown in red) relative to the CAD design models (shown in blue).

In response to the discovery of the retraction anomaly, the ISS Program Office abandoned efforts to relocate the PMM to the aft Node 3 CBM and has issued a change request to relocate it to the forward Node 3 CBM. The Shuttle Engineering Change Implementation Board (SECIB) has also requested that ISAG perform a photogrammetric analysis of the starboard FGB solar array to document its current configuration.

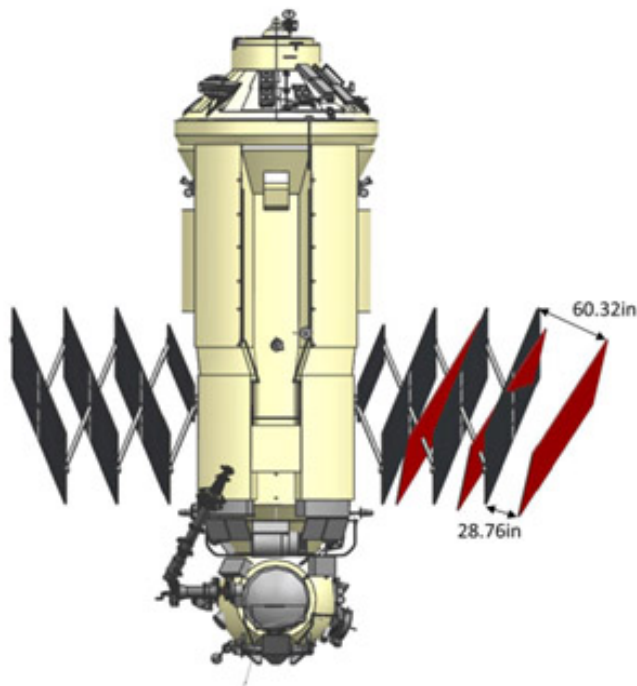
Figure 5.— Delta configuration between the measured coordinates of the port solar array (shown in red) relative to the CAD design models (shown in gray).

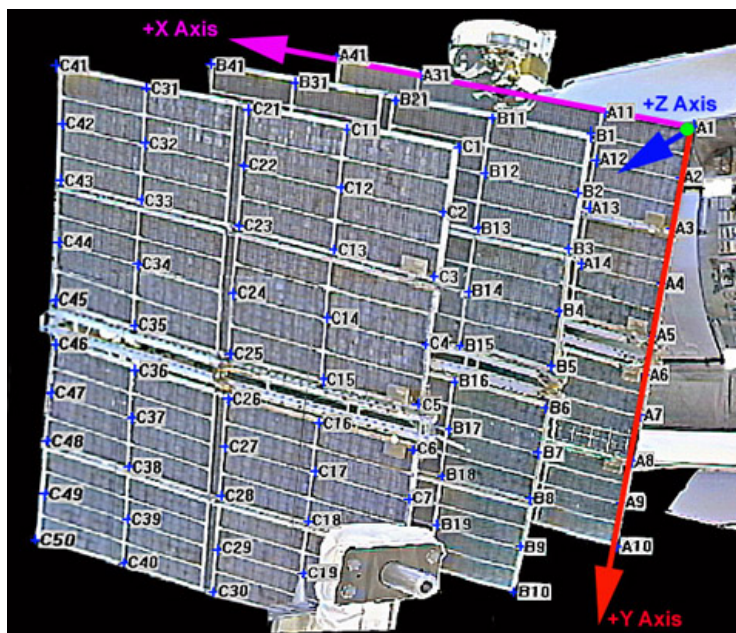
The unexpected comparison results produced some initial concern regarding the accuracy of the photogrammetric measurements. To verify the measured results, ISAG personnel conducted a second analysis using just the imagery of the solar arrays in an arbitrary coordinate system defined

by the three corner points of the inboard-most panel, with the design distance between points A1 and A10 as the only scale (see figure 6).

*Figure 6.— Control for second analysis.*

The new measurements agreed with the original results to within less than 1 in. RMS in each axis, confirming the original solar array measurements.

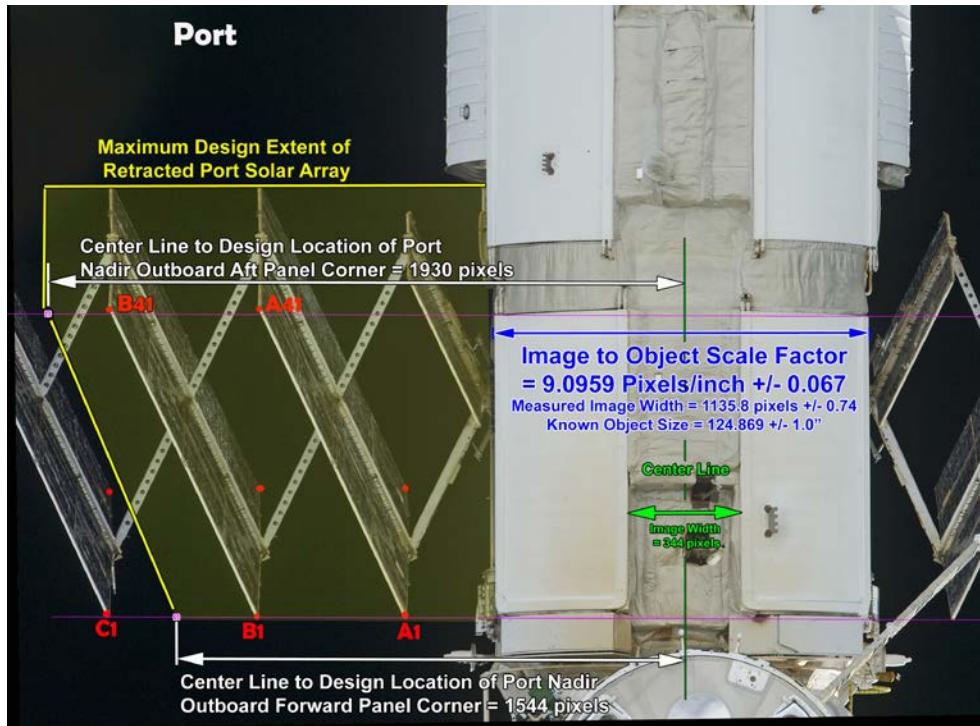
On November 10, 2012, during a face-to-face meeting with their Russian counterparts at JSC, ISAG presented nadir-view imagery of the FGB acquired during Space Shuttle rendezvous. Using the known width of the pressurized portion of the FGB as a scale, this analysis clearly showed that the port FGB solar array was extended outboard further than the Russian design for the retracted solar array (see figure 7).

Figure 7.— Single camera measurement of the port FGB solar array.

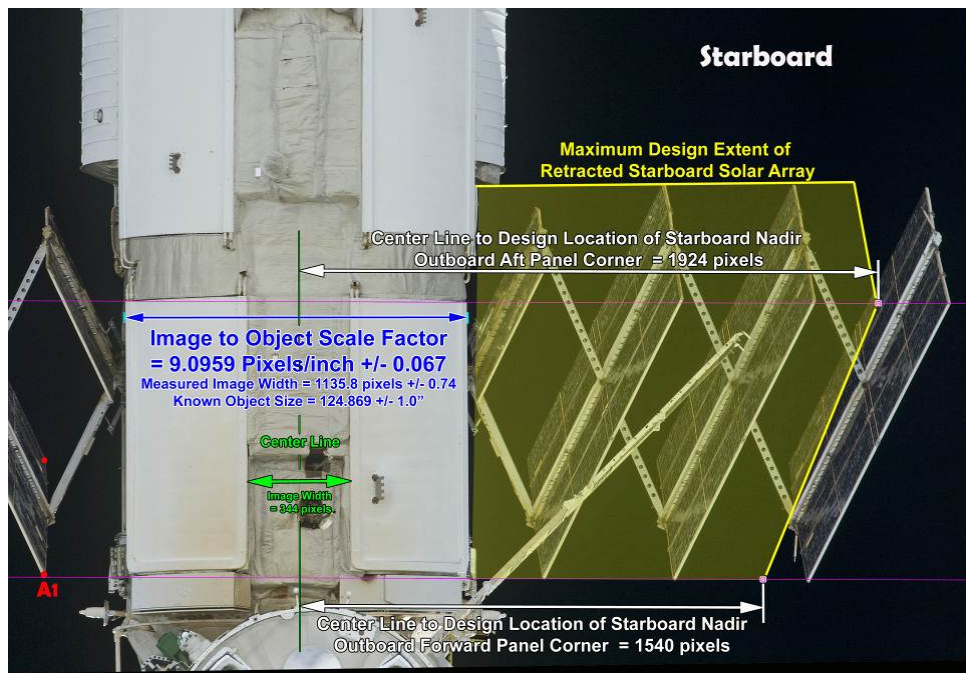
The same photo contained the image of the starboard FGB solar array. A similar analysis revealed that it also exceeded the designed retraction state (see figure 8).

Figure 8.— Single camera measurement of the starboard FGB solar array.
